Fisheries Habitat Evaluation – Unnamed Tributary to Scoggins Creek Below Scoggins Dam

PREPARED FOR: Lisa Obermeyer, Montgomery Watson Harza

PREPARED BY: Greg White, CH2M HILL
Jamey Tielens, CH2M HILL

DATE: June 14, 2003

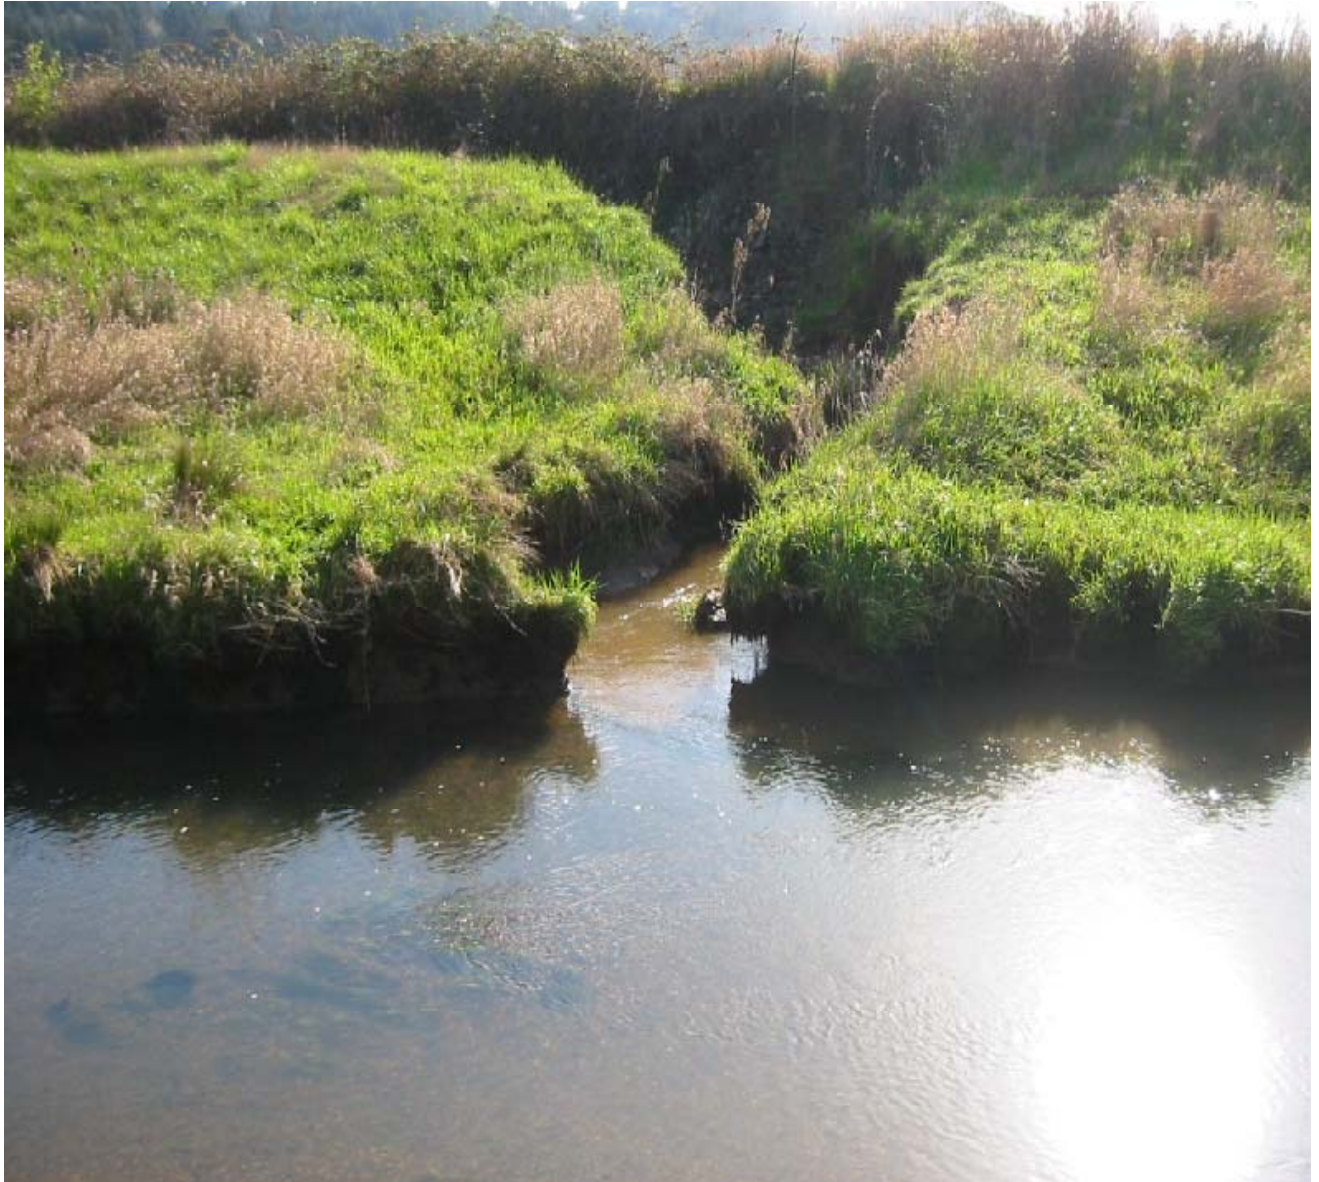
FIGURE 1. CONFLUENCE OF UNNAMED TRIBUTARY AND SCOGGINS CREEK DOWNSTREAM OF SCOGGINS DAM.

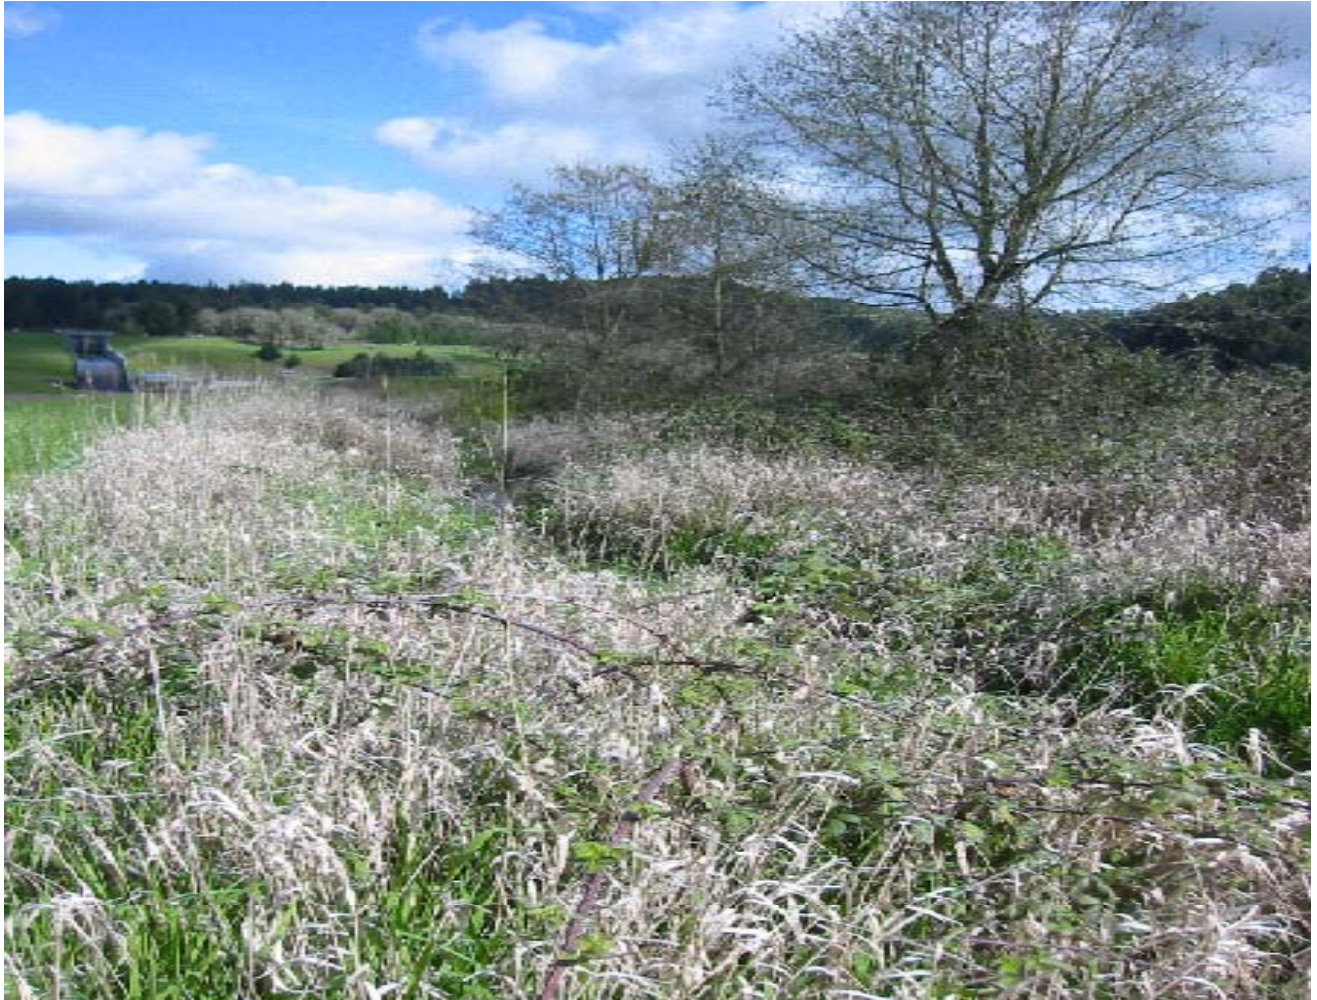
Reach 1 extends from the confluence of the tributary with Scoggins Creek, approximately 1,470 feet upstream to the BOR road crossing. The reach has a low gradient (from 1 to 2 percent). This reach is approximately 85 percent glide and 14 percent riffle, with very little pool habitat. The main understory and overstory consist primarily of various grasses and Reed Canary Grass with limited scattered trees (Figure 1). Stream substrate is mostly sand and silt with some gravels. This reach appears to be artificially channelized to prevent

FIGURE 2. UNDERSTORY AND OVERSTORY CONSISTING PRIMARILY OF VARIOUS GRASSES AND REED CANARY GRASS WITH LIMITED SCATTERED TREES.

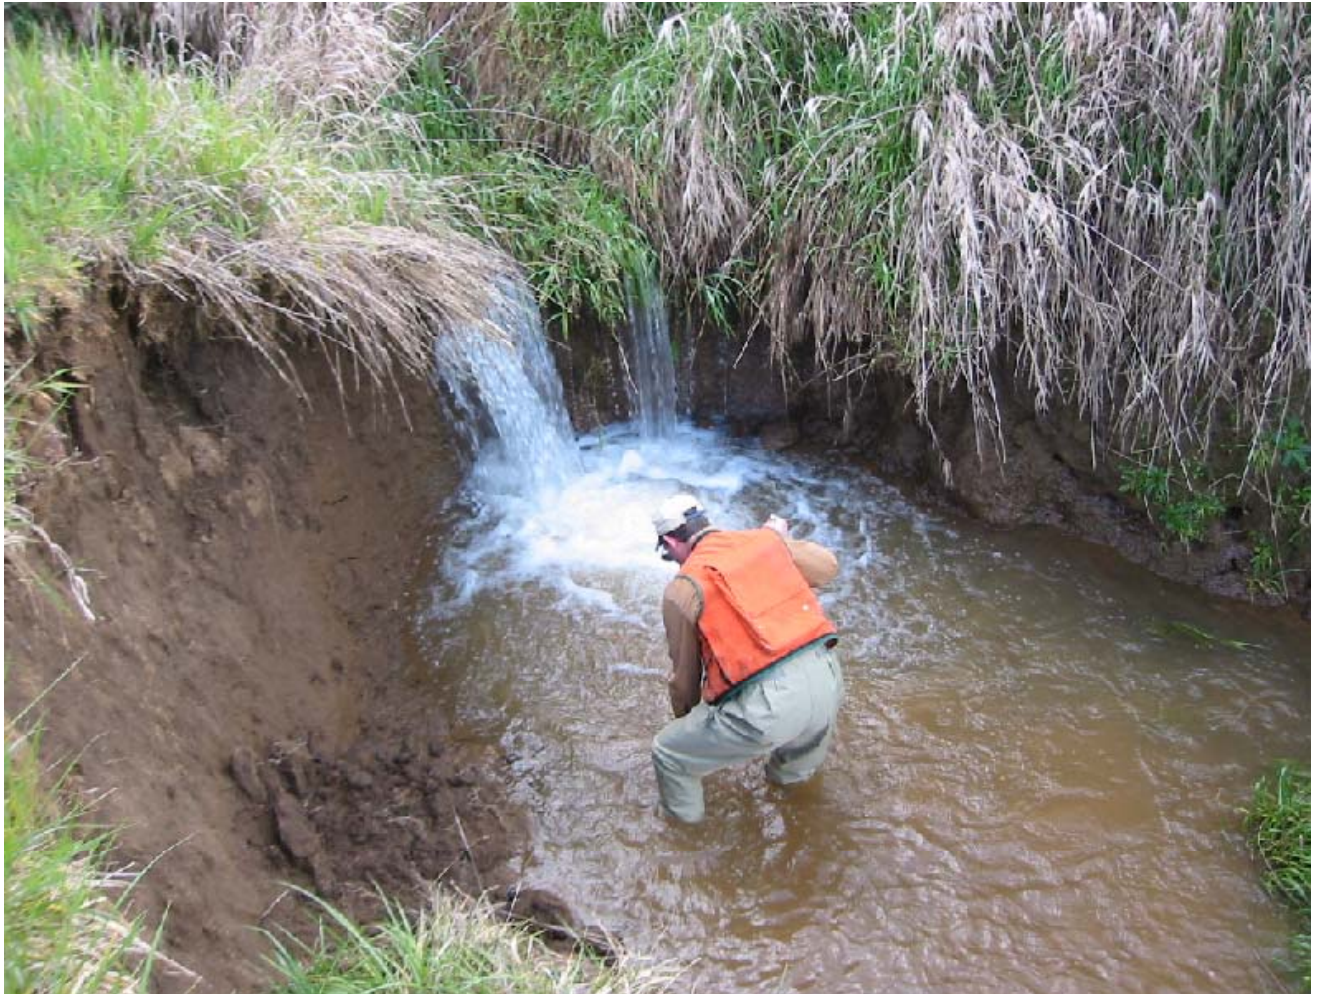
At the time of the reconnaissance survey, the discharge of the tributary was visibly more turbid than the mainstem Scoggins Creek, creating a plume of turbid water downstream of the confluence in Scoggins Creek. The majority of the turbidity appears to be caused by sloughing banks and headcutting approximately 100 feet upstream of the confluence (Figure 2). The headcutting creates an impassable barrier to at least resident fish. The headcut, or step, is approximately 4 feet high and is likely caused by active headcutting of the tributary. Headcutting is a unique process by which the channel downcuts (degrading) in a downstream to upstream process. Upstream of the headcut, the instream substrate is dominated by gravel. Instream vegetation, dominated by grasses, also begin to appear and continue throughout the reach. The remainder of the reach does not experience visible bank sloughing.

FIGURE 3. SLOUGHING BANKS AND HEADCUTTING APPROXIMATELY 100 FEET UPSTREAM OF THE CONFLUENCE WITH SCOGGINS CREEK.

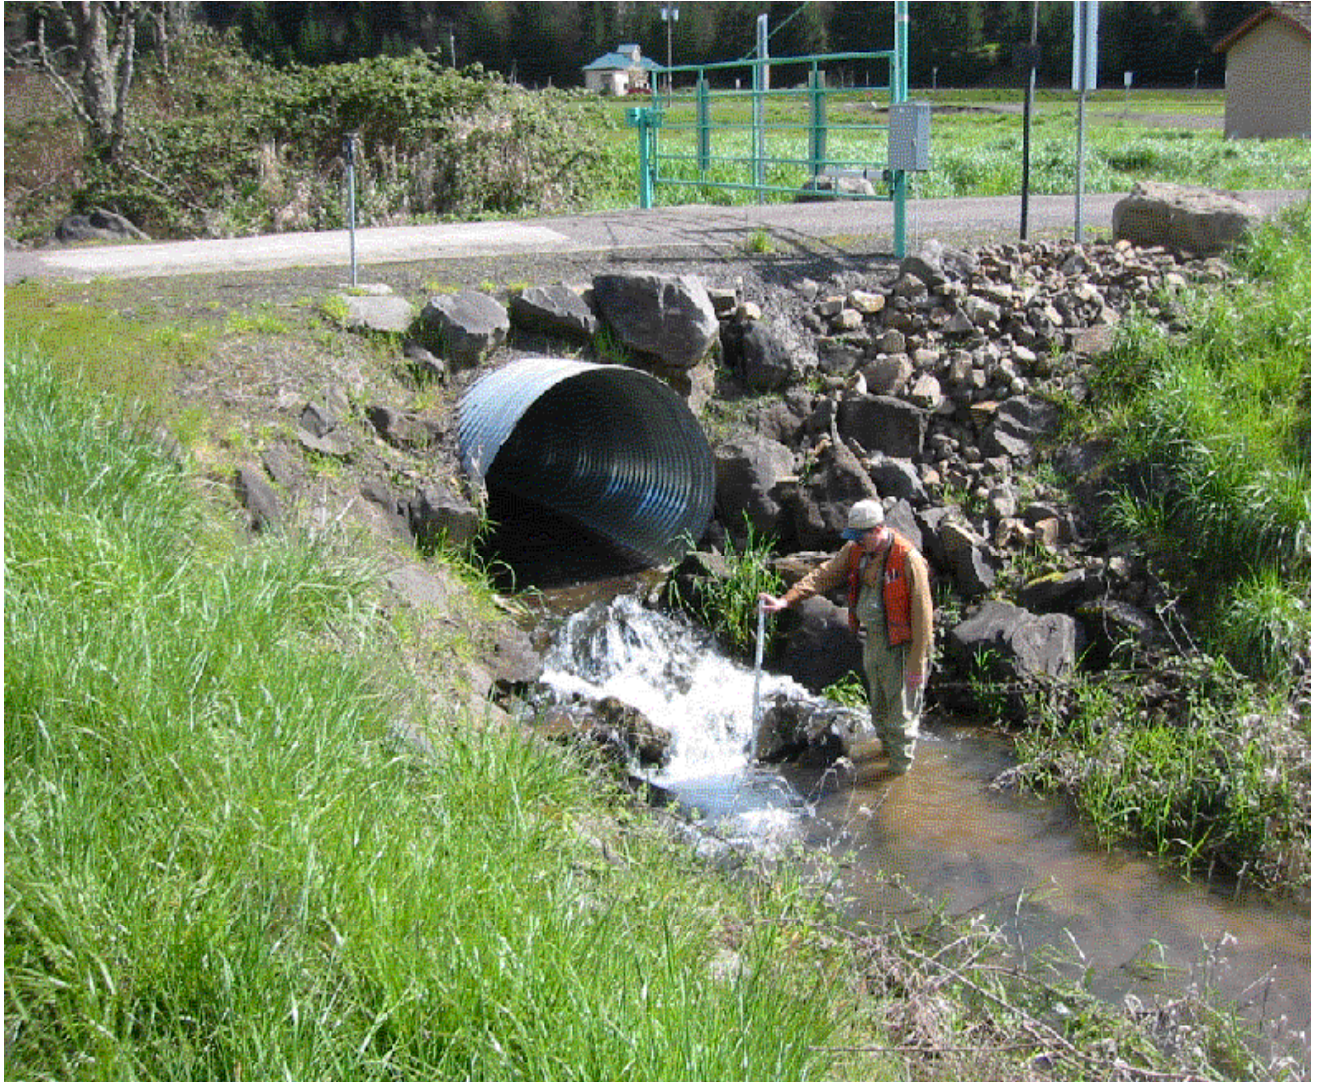
Approximately 985 feet upstream the channel bends to the north over a small 1.5 feet step. From this point, upstream to the end of the reach, the understory and overstory is dominated by grasses; no blackberry plants or trees exist throughout the end of the reach. The culvert located at the BOR road crossing at the end of the reach creates a potential barrier to fish passage at low flows due to a slight perch (Figure 3).

FIGURE 4. U.S. BUREAU OF RECLAMATION ROAD CROSSING AT THE END OF THE REACH 1 CREATING A POTENTIAL BARRIER TO FISH PASSAGE AT LOW FLOWS.

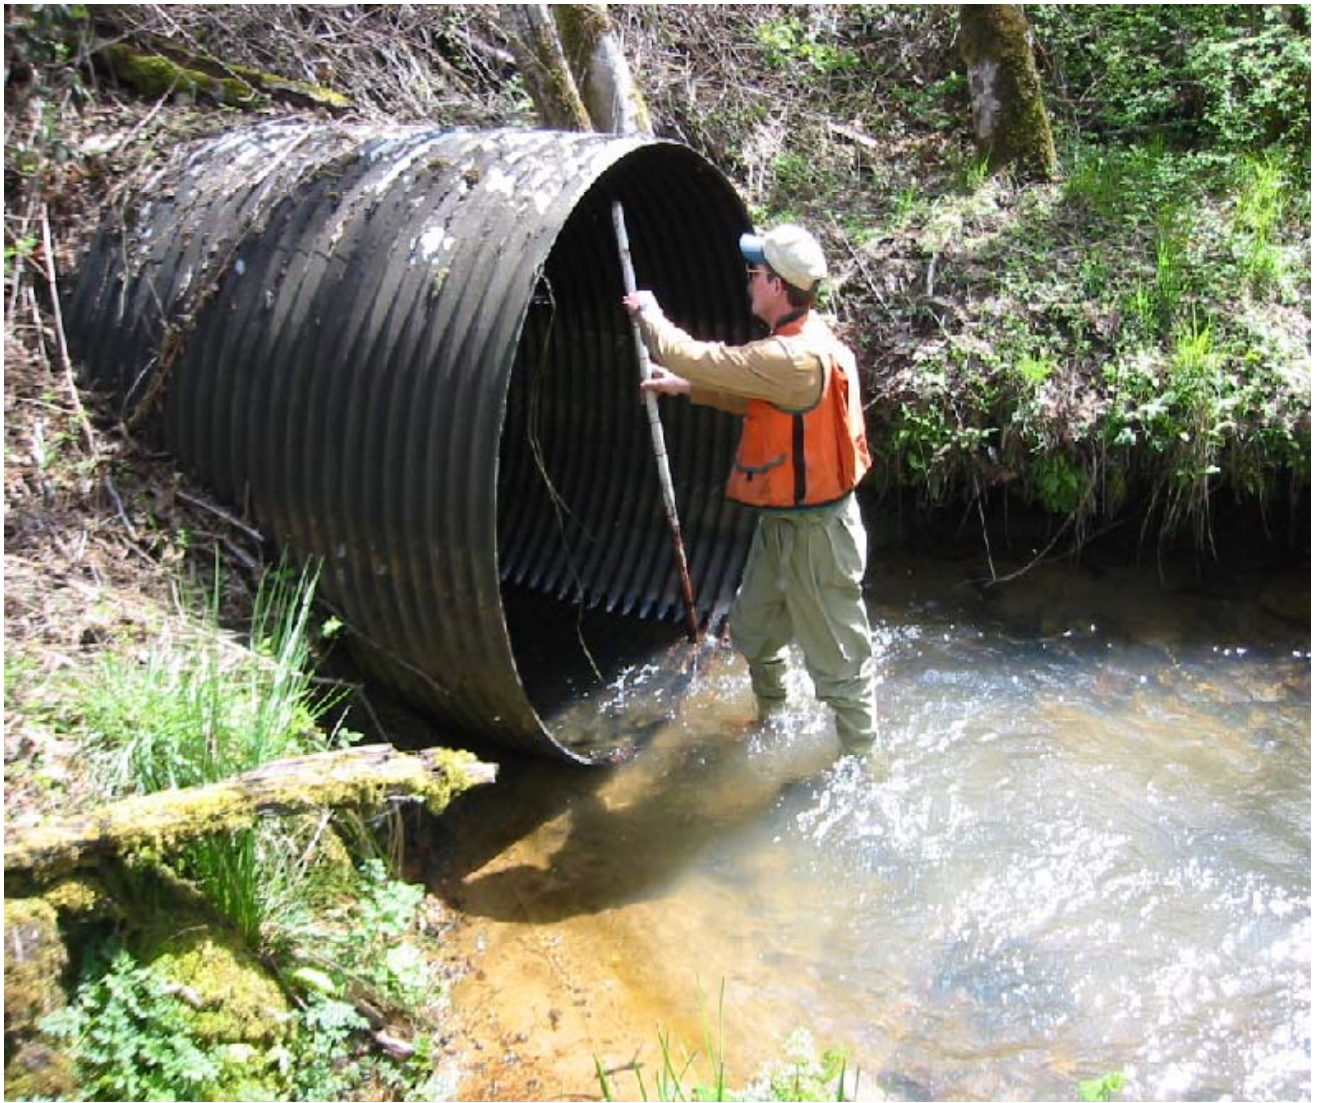
This reach has increased instream habitat diversity, as well as riparian vegetation and higher canopy cover as compared to Reach 1. As a result, Reach 2 is less temperature sensitive than Reach 1. The reach contains two potential impassable barriers. The first is a day-lighting pipe located approximately 350 feet upstream of the BOR crossing. The second is the culvert at the Scroggins Valley Road crossing (Figure 4). The gradient of the culvert is approximately 3 to 4 percent creating an upstream passage barrier.

FIGURE 5. CULVERT AT THE SCOGGINS VALLEY ROAD CROSSING WITH A GRADIENT OF APPROXIMATELY 3 TO 4 PERCENT CREATING AN UPSTREAM PASSAGE BARRIER.
